REPORT BMS21

Structural Properties of a
Concrete-Block Cavity-Wall
Construction Sponsored by the
National Concrete Masonry
Association

Structural Properties of a Concrete-Block Cavity-Wall
Construction Sponsored by the
National Concrete Masonry Association

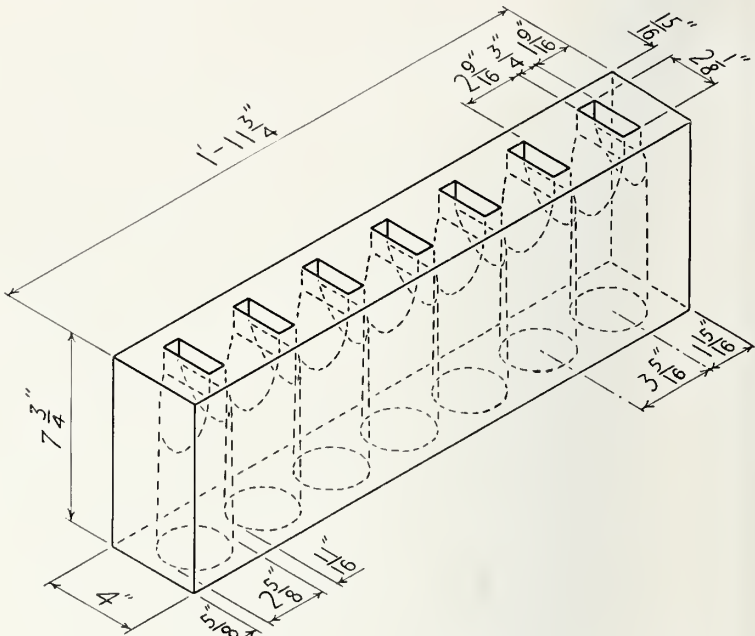
FIGURE 1.—Concrete block.

um size $\frac{3}{8}$ in.), by volume. The average dimensions were 4.00 by 23.75 by 7.73 in. (about 4 by 1 ft. 11 $\frac{3}{4}$ in. by 7 $\frac{3}{4}$ in.) for the full-sized blocks and 4.00 by 11.83 by 7.78 (about 4 by 11 $\frac{1}{8}$ by 7 $\frac{3}{4}$ in.) for the half-sized blocks. The full-sized block is shown in figure 1. The half-

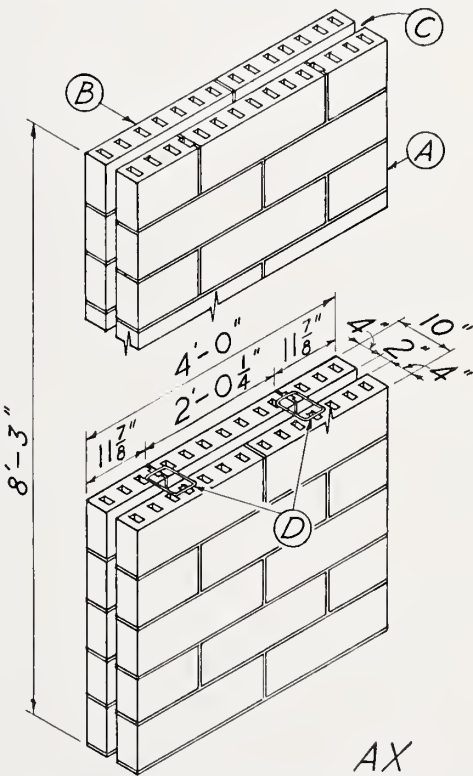
FIGURE 2.—Four-foot wall specimen AX. A, facing; B, backing; C, air space; D, wall ties.

(1) Four-foot wall specimens.—The 4-ft wall specimens were 8 ft 3 in. high, 4 ft 0 in. wide, and 10 in. thick. The specimens were built with a concrete-block facing, A, and backing, B, as shown in figure 2, separated by an air space, C, and connected by steel wall ties, D.

There were 12 courses in the facing and 12 in the backing. The first course in the facing had two full-sized blocks. The first course in the backing had a full-sized block and two half-sized blocks. There were two wall ties, located as shown in figure 2, in each alternate bed joint starting with the joint above the first course.

The bed joints were furrowed and only the outer edges of the head joints were buttered with mortar.

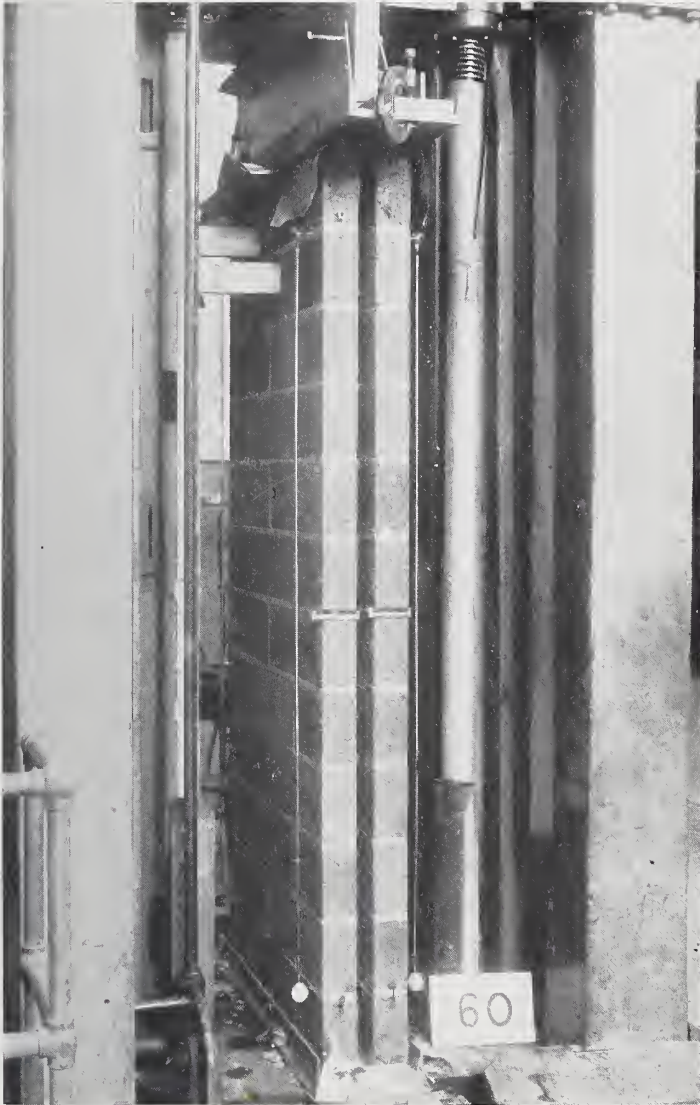
FIGURE 3.—Wall specimen AX-C1 under compressive load.

Wall specimen AX-C1 under compressive load is shown in figure 3. The results for wall specimens AX-C1, C2, and C3 are shown in table 6 and in figures 4 and 5.

Each of the specimens failed by crushing of blocks in the backing in one or more courses near the upper end of the specimen.

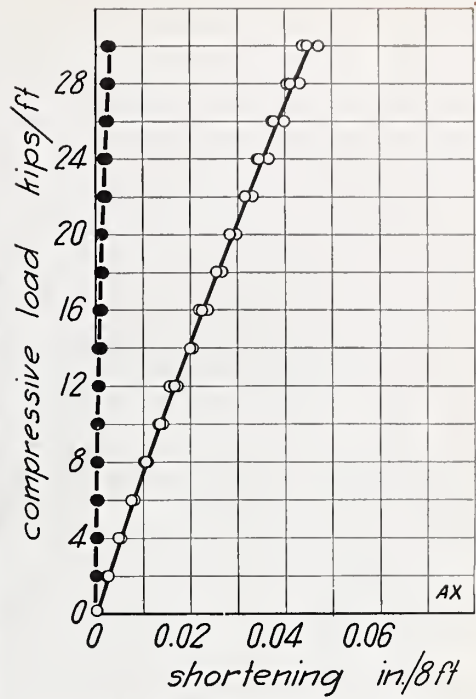
FIGURE 4.—Compressive load on wall AX. Load-shortening (open circles) and load-set (solid circles) results for specimens AX-C1, C2, and C3. The load was applied 3.33 in. from the inside face. The loads are in kips per foot of actual width of specimen.

The compressive loads were applied to both the facing and the backing, 3.33 in. from the inside face. The shortenings and sets shown in figure 4 for a height of 8 ft were computed from the values obtained from the compressometer readings. The gage length of the compressometers was 6 ft 11 in. The lateral deflections shown in figure 5 were measured on the backing. The facing deflected the same amount as the backing within 0.01 in., the estimated error of measurement.

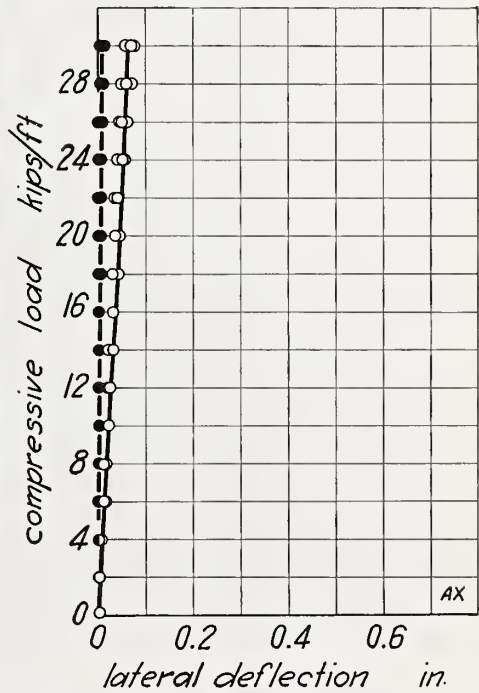
FIGURE 5.—Compressive load on wall AX. Load-lateral deflection (open circles) and load-lateral set (solid circles) results for specimens AX-C1, C2, and C3. The load was applied 3.33 in. from the inside face. The loads are in kips per foot of actual width of specimen. The deflections and sets are for a gage length of 7 ft 1 in., the gage length of the deflectometers.

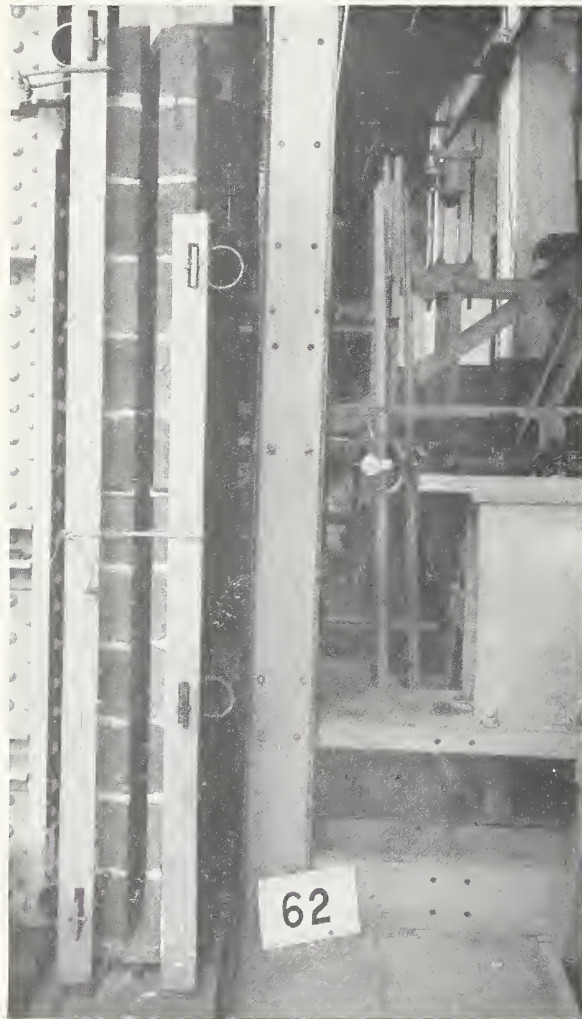
FIGURE 6.—Wall specimen *AX-T1* under transverse load.

Wall specimen *AX-T1* under transverse load is shown in figure 6. The results for wall specimens *AX-T1*, *T2*, and *T3* are shown in table 6 and in figure 7.

Each of the specimens failed by rupture of the bond between the blocks and the mortar in both the facing and the backing at bed joints

at or between the loading rollers. For specimens *T1* and *T3* the failure occurred at joints having no ties and the ruptured joints in the facing and backing were at the same height. For specimen *T2* the failure in the facing occurred at a joint having no ties, whereas the failure in the backing occurred at a joint having ties.

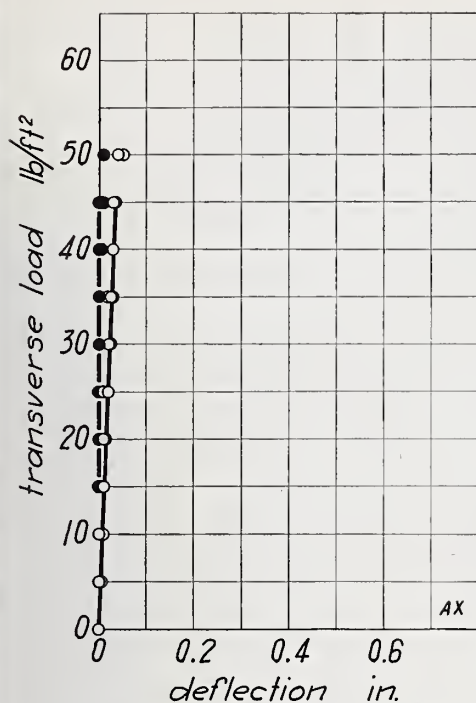
FIGURE 7.—Transverse load on wall AX.

Load-deflection (open circles) and load-set (solid circles) results for specimens AX-T1, T2, and T3 on the span 7 ft 6 in. The deflections and sets are for the gage lengths of the deflectometers. For specimen T1 the gage length was 7 ft 1 in., and for specimens T2 and T3 the gage length was 7 ft 6 in.

The lateral deflections shown in figure 7 were measured on the backing. The facing deflected the same amount as the backing within 0.01 in., the estimated error of measurement.

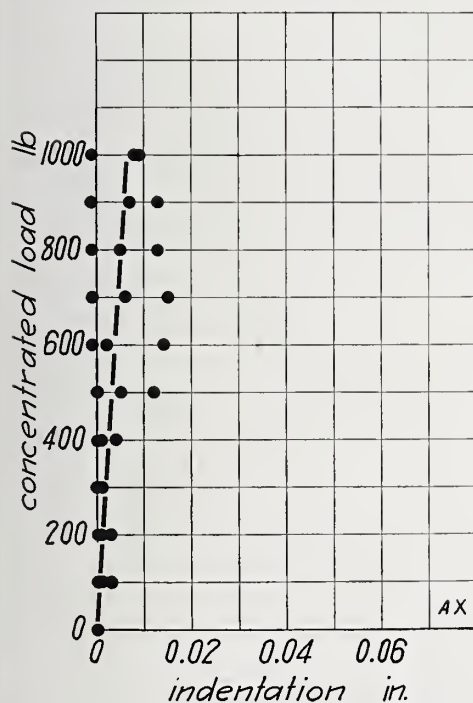
FIGURE 9.—Concentrated load on wall AX.

Load-indentation results for specimens AX-P1, P2, and P3.

The indentations shown in figure 9 to the left of the vertical axis and the decrease in the indentation for one specimen for loads greater than 700 lb were caused by the difficulty of obtaining readings on the rough surfaces of the specimens. The indentations after a load of 1,000 lb had been applied were less than 0.015 in. for each of the specimens, and no other effect was observed.

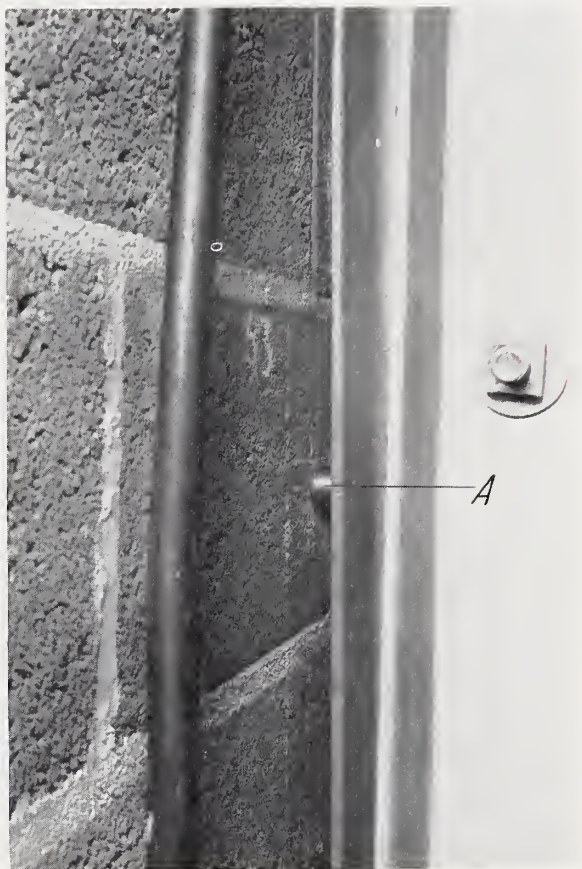
FIGURE 8.—Wall specimen AX-P3 under concentrated load.

A, loading disk.

Wall specimen *AX-P3* under concentrated load is shown in figure 8. The results for wall specimens *AX-P1*, *P2*, and *P3* are shown in table 6 and in figure 9.

The concentrated loads were applied to one face of each specimen at midwidth. For specimen *P1* the load was applied on a head joint, for specimen *P2* at the intersection of a head joint and a bed joint having no ties, and for specimen *P3* at the center of a concrete block.

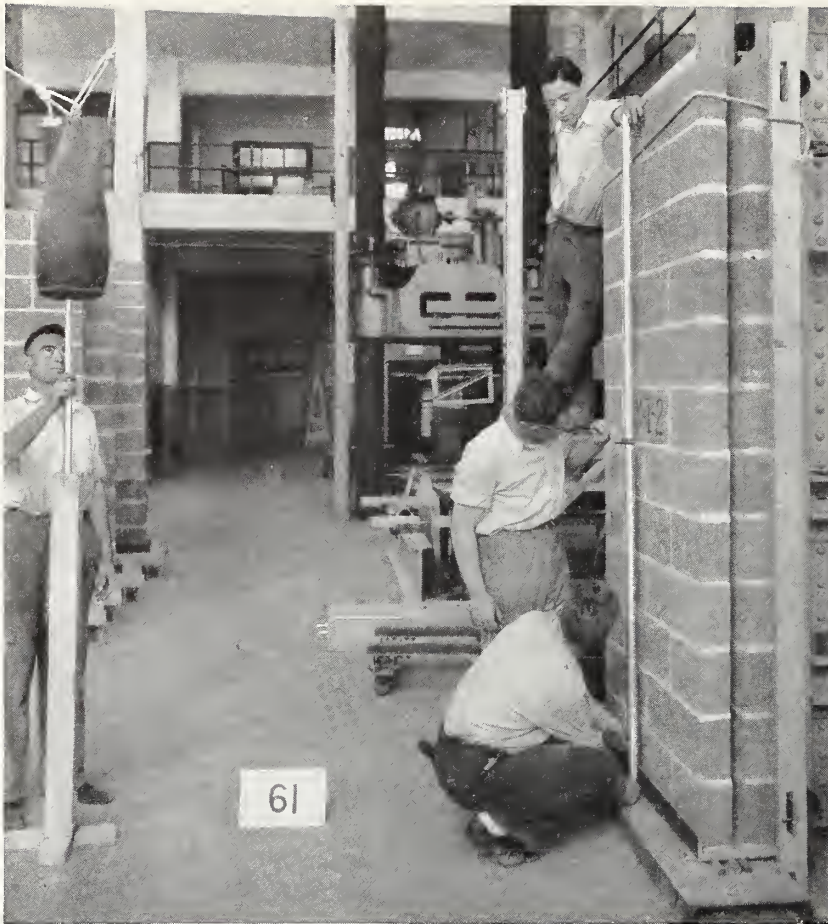
FIGURE 10.—Wall specimen AX-12 during the impact test.

Wall specimen *AX-I2* during the impact test is shown in figure 10. The results for wall specimens *AX-I1*, *I2*, and *I3* are shown in table 6 and in figure 11.

The impact loads were applied to the center of one face of each specimen, the sandbag striking the face about midway, between wall ties. At drops of 1.5, 2.5, and 2 ft for specimens *I1*, *I2*, and *I3*, respectively, a bed joint near midheight in both the facing and the backing cracked. At the maximum drop each specimen failed by rupture of the bond between the blocks and the mortar at the cracked bed joints. For specimens *I2* and *I3* the failures occurred at joints having ties.

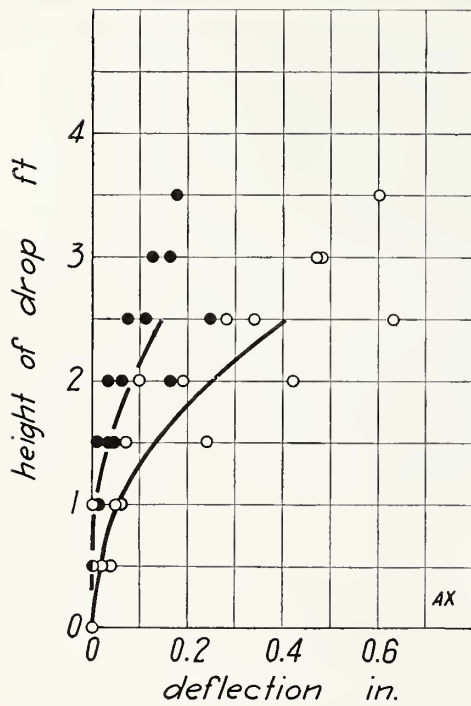
FIGURE 11.—*Impact load on wall AX.*

Height of drop-deflection (open circles) and height of drop-set (solid circles) results for specimens *AX-I1*, *I2*, and *I3* on the span 7 ft. 6 in.

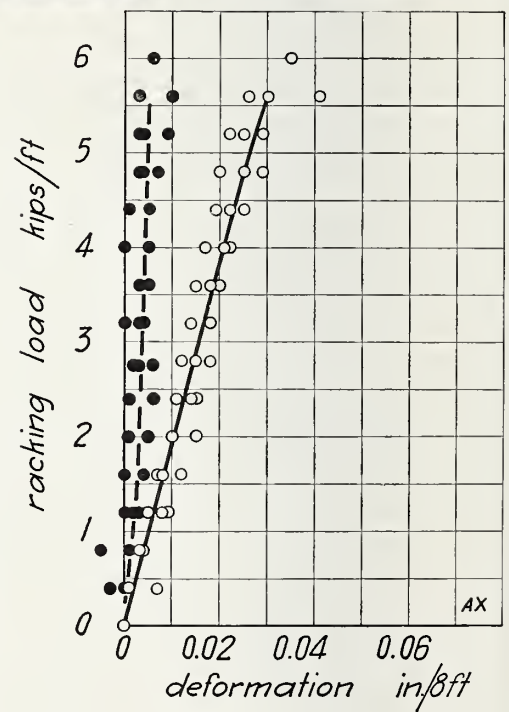
FIGURE 13.—*Racking load on wall AX.*

Load-deformation (open circles) and load-set (solid circles) results for specimens *AX-R1*, *R2*, and *R3*. The loads are in kips per foot of actual width of specimen.

The racking loads were applied near the upper end of each specimen to a bearing plate covering both the facing and the backing and the stop was also in contact with both. The deformations and sets shown in figure 13 for a height of 8 ft were computed from the values obtained by the measuring-device readings. The gage length of the vertical measuring device was

6 ft 6 in. for specimen *R1* and 6 ft 1 in. for specimens *R2* and *R3*. The gage length of the horizontal measuring device was 5 ft 0 in. for all three specimens.

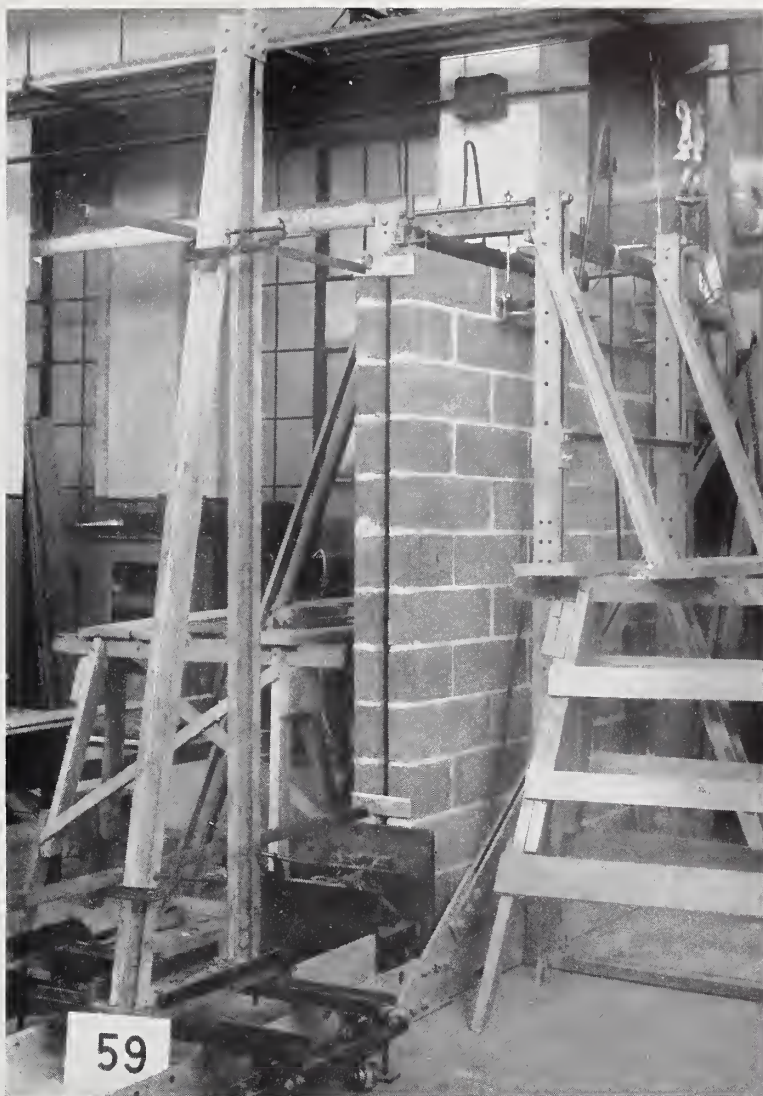
FIGURE 12.—Wall specimen *AX-R1* under racking load.

Wall specimen *AX-R1* under racking load is shown in figure 12. The results for wall specimens *AX-R1*, *R2*, and *R3* are shown in table 6 and in figure 13.

Specimen *R1* failed by crushing of blocks in both the facing and the backing at the loaded corner. Specimens *R2* and *R3*, failed by rupture of both the facing and the backing approximately along a diagonal between the point of application of load and the stop. The cracks did not follow the mortar joints but went directly through the blocks. In addition, for specimen *R3* two blocks at the stop crushed.
